TECHNICAL ASSISTANCE TEAM FOR EMERGENCY RESPONSE REMOVAL AND PREVENTION  
EPA CONTRACT 68-01-6669

March 3, 1986

TAT-05-F-00809

Re: I.J. Recycling, Ft. Wayne, Indiana  
TUD# 5-8601-02

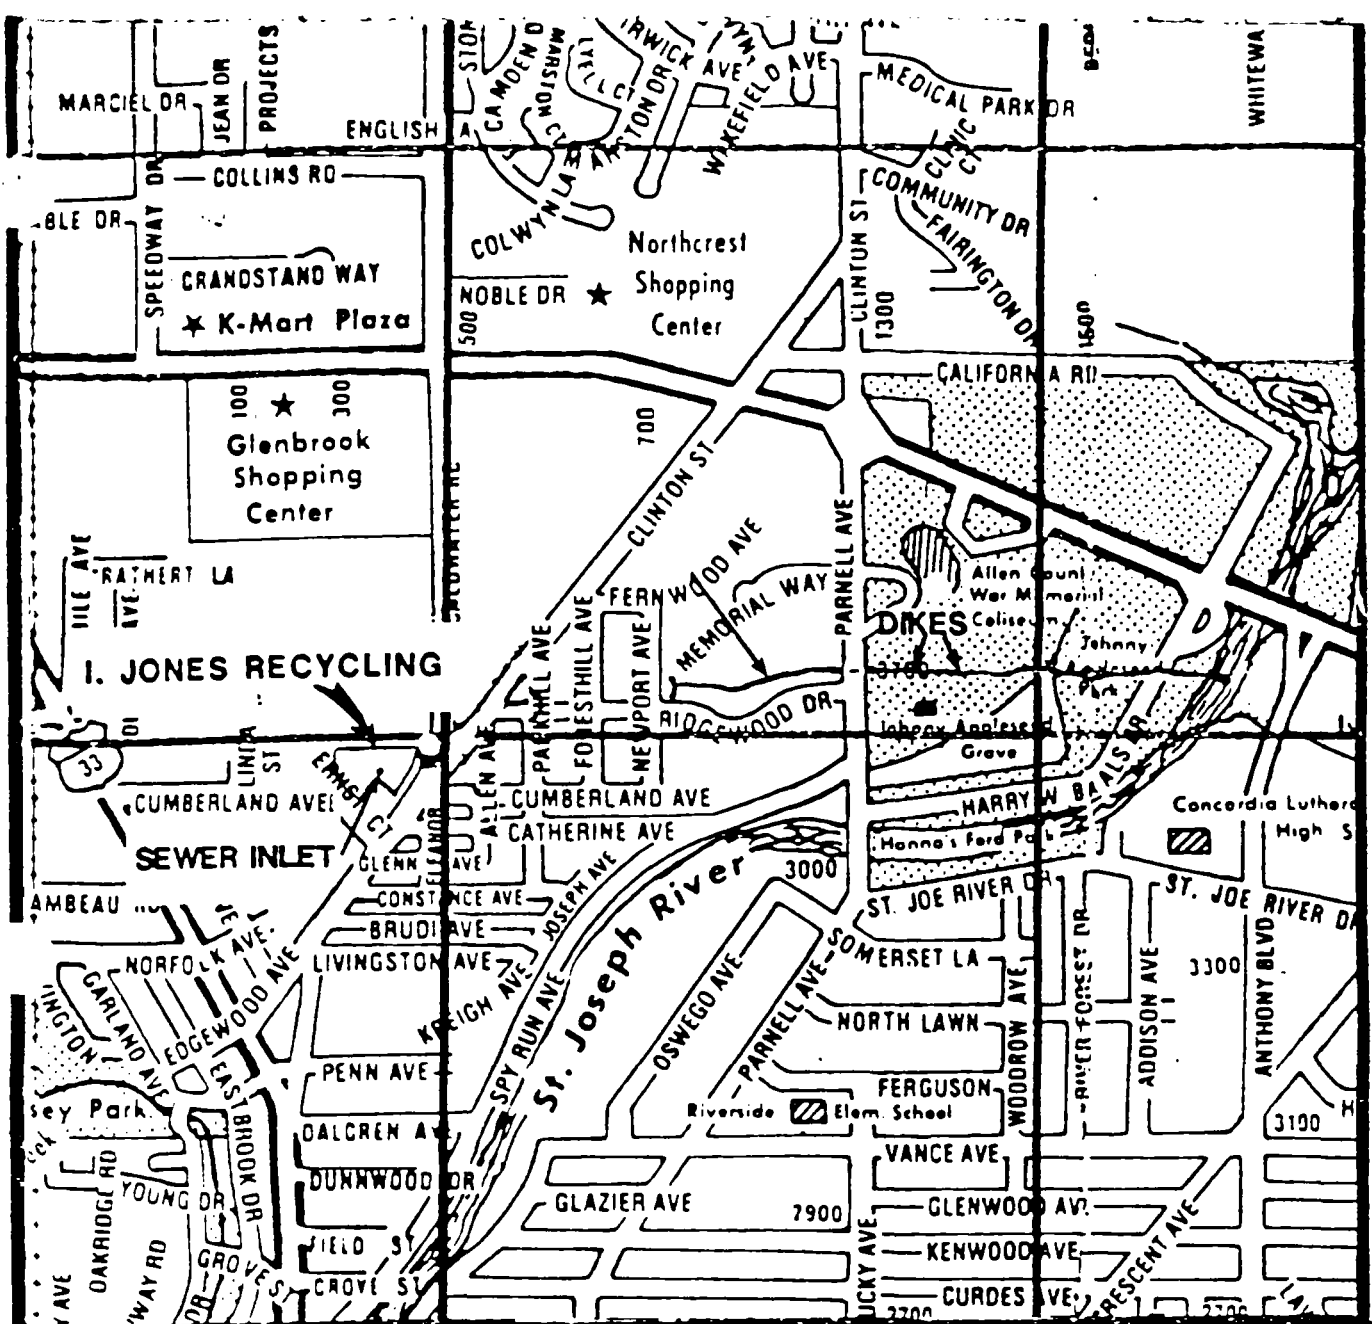
**FIGURE 3**  
**SPILL PATHWAY**  
**I. JONES RECYCLING**  
**FORT WAYNE, INDIANA**

The storm sewer extends 0.5 miles below ground and discharges into an open-flow run-off channel (Figure 3). The channel is approximately 4 to 10 feet in width and 1.5 miles in length and flows through a residential area and city park prior to discharging into the St. Joseph River. The discharge point is located downstream of the Ft. Wayne drinking water intake. There are no known drinking water wells in the area.
